National Aeronautics and  
Space Administration

**Goddard Space Flight Center**  
Greenbelt, Maryland  
20771

**SUBJECT:** Hydra-Set Incident Investigation Report

## INTRODUCTION

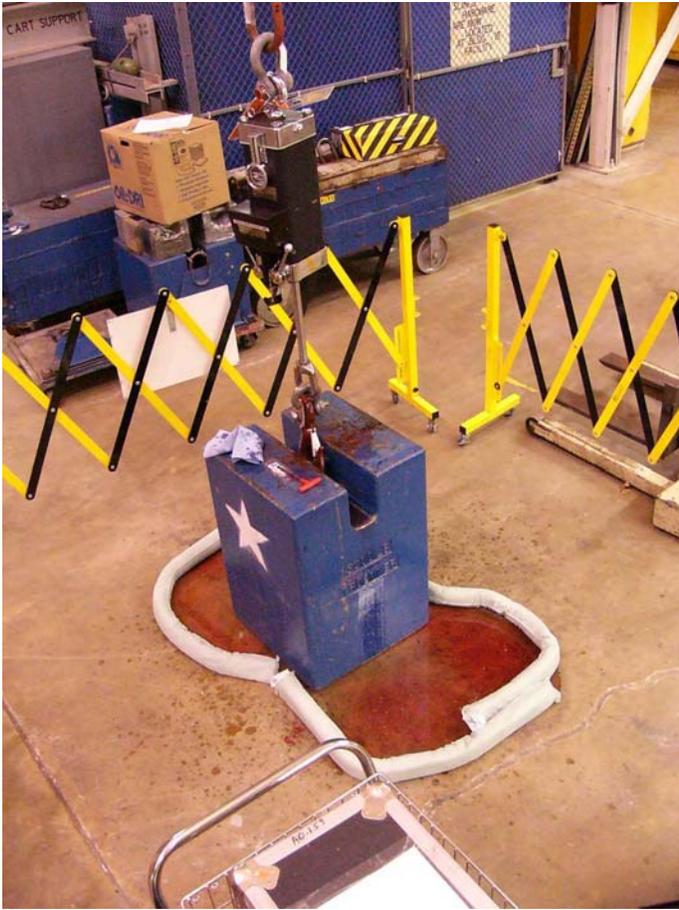
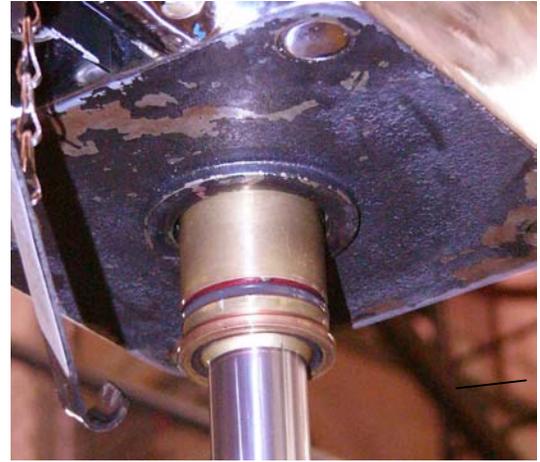
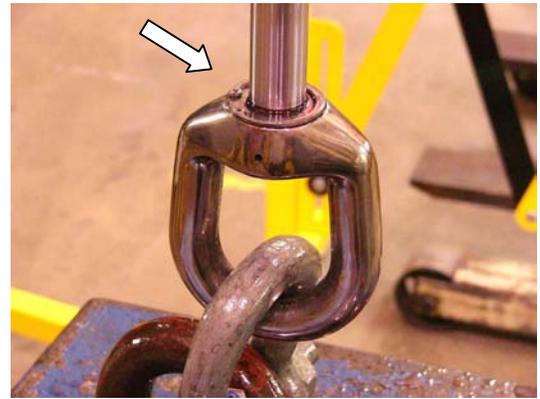
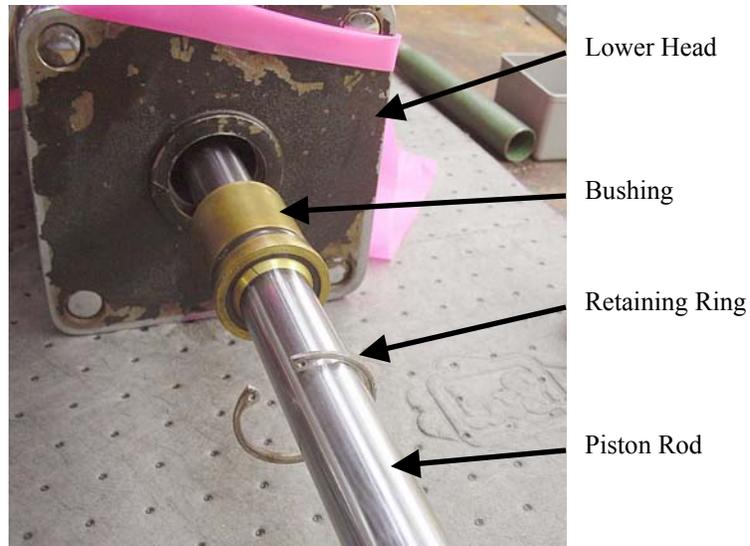
FIG.1 Model "B" S/N A2-420 Hydra-Set after the incident.

These photographs show the Hydra-Set just after it let go. The close ups show the retaining ring (white arrow) captured by the clevis as it fell out and the ring assembly (top) that came out of the lower head following the ring.

The Hydra-Set is on the bench top awaiting for disassembly after the incident.

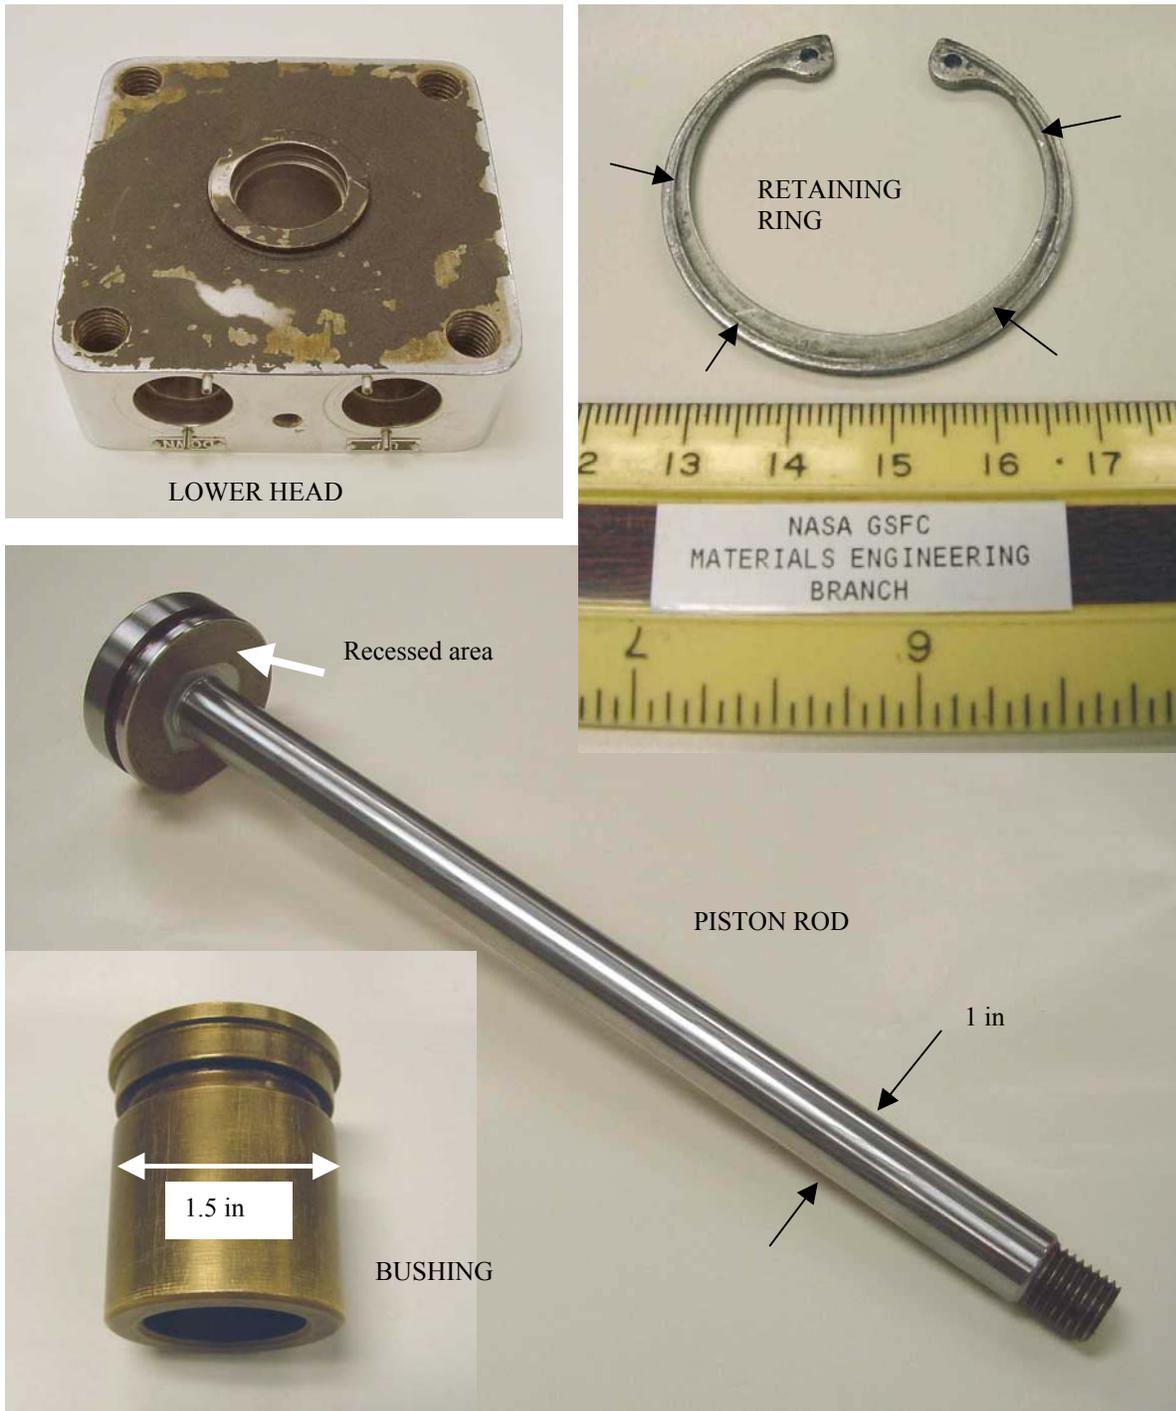
The failed Hydra-Set was disassembled and the ring assembly components such as the retaining ring, bushing, piston rod and the lower head were delivered to the Materials Engineering Branch (MEB) for the evaluation, see Fig.2. All components were found to be physically intact with no material and dimensional discrepancies, except for the excessively deformed retaining ring and some minor scratches on the inner groove edge of the lower head. In order to better understand the interaction between the

FIG. 2 Hydra Set components delivered to the Materials Branch for examination. Note that piston has a recessed area to prevent mechanical contact with the bushing. The retaining ring has a “footprint” line (black arrows) from the contact with the abutting edge of the inner groove.

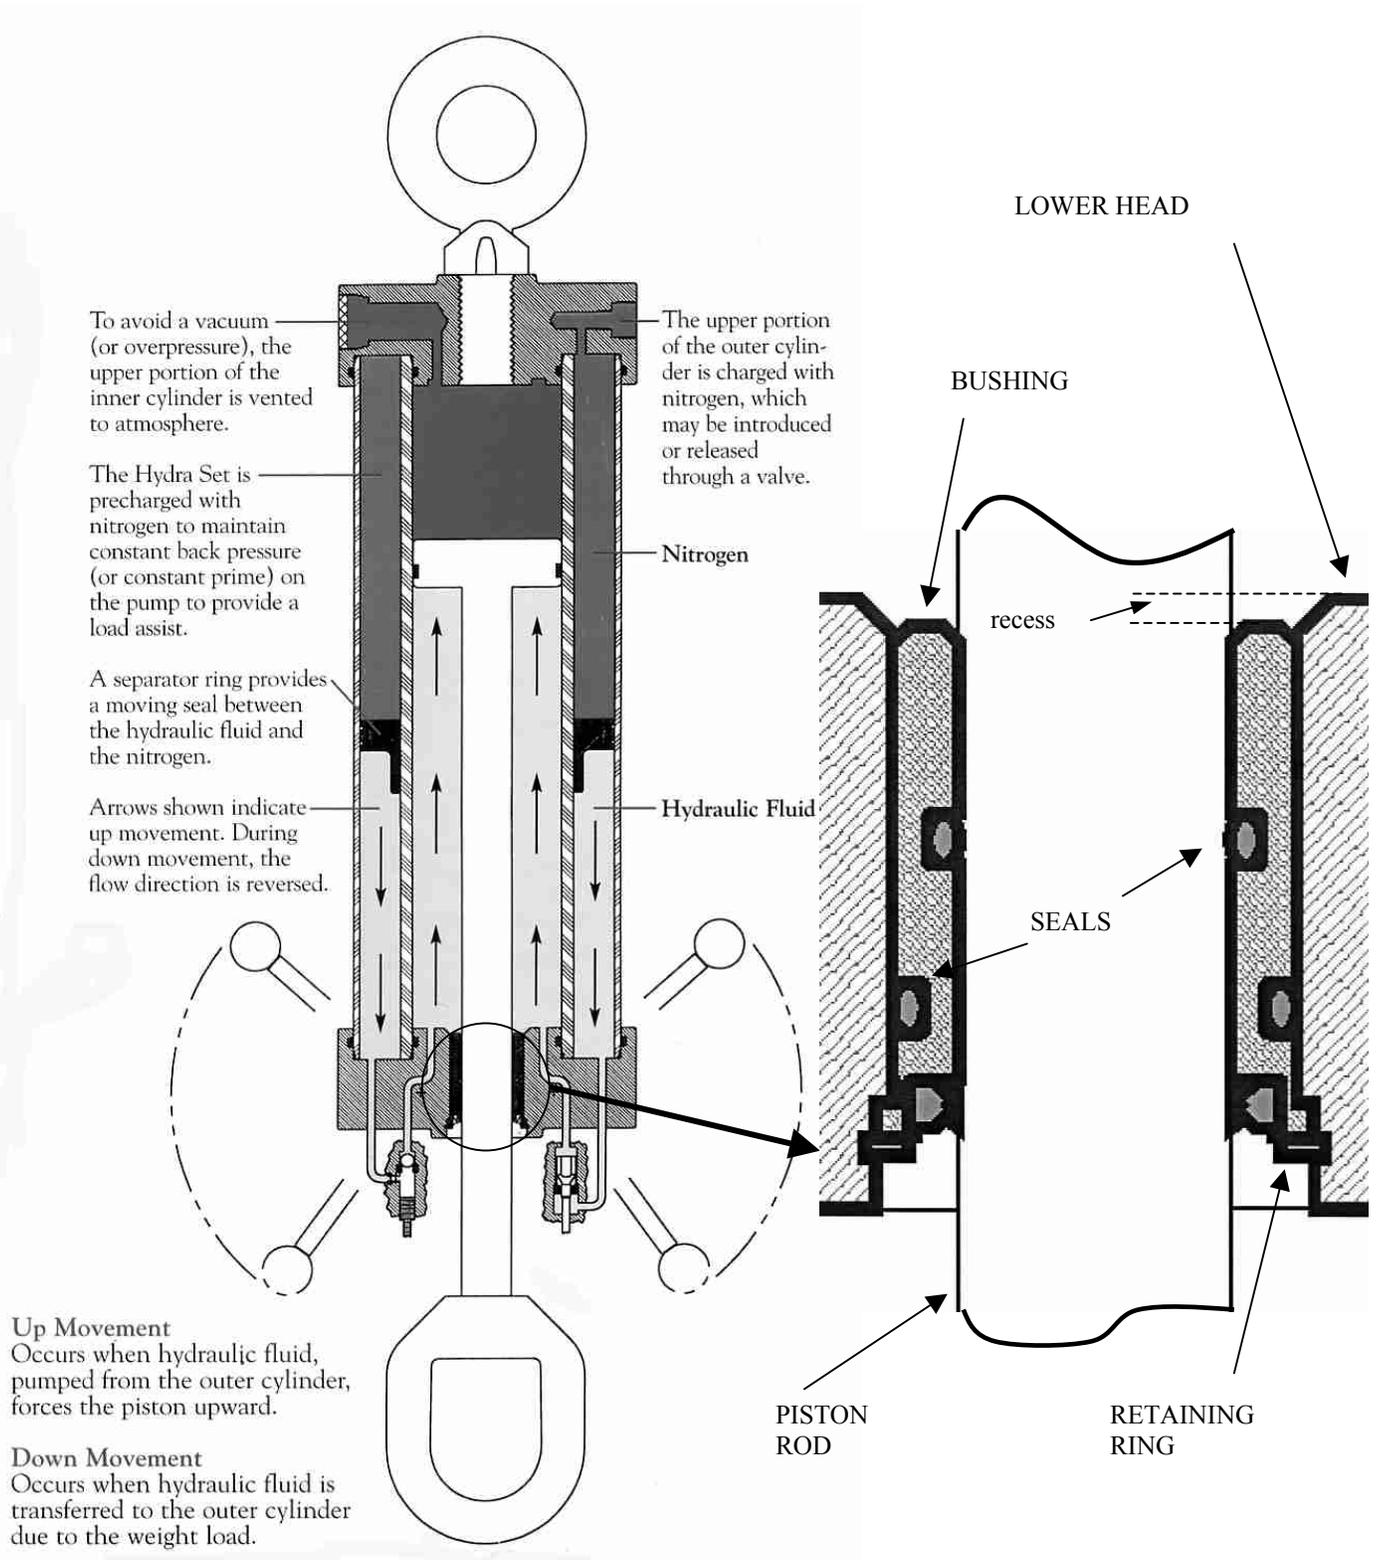
The Hydra-Set under investigation is a manually operated 5000 lbs load capacity hydraulic actuator capable of positioning loads in very small vertical increments, see Fig.3 It was placed in service at GSFC in 1988. Since then it had been used numerous times for positioning of critical hardware. The factory trained and certified GSFC personnel had performed all inspection, cleaning, overhaul and re-certification procedures, except for one time when the unit was sent to the manufacturer in 1997.

The piston rod bushing was visually examined for possible defect and dimensional discrepancies. Examination of the bushing revealed no unusual scratch marks around its outer edge. The edge radius was about 0.016 in which is roughly  $\frac{1}{4}$  of the maximum corner radius of 0.064 in specified by the ring manufacturer. By design, the bushing cannot make a physical contact with the piston, when the latter bottoms out on the inner face of the lower head, see Fig.3

An examination of the piston rod revealed no anomalies. The recess machined on the inner face of the piston helps to assure that the piston does not make any physical contact with the bushing, see Fig.3

FIG.3 A cross section of the Hydra Set that explains its operation. An expanded view on the right shows the details of the retaining ring assembly. Note that the bushing is located below (dashed lines on the expanded view) the inner face of the lower head. This design feature assures that the piston never makes a physical contact with the bushing when it bottoms out against the internal face of the lower head.

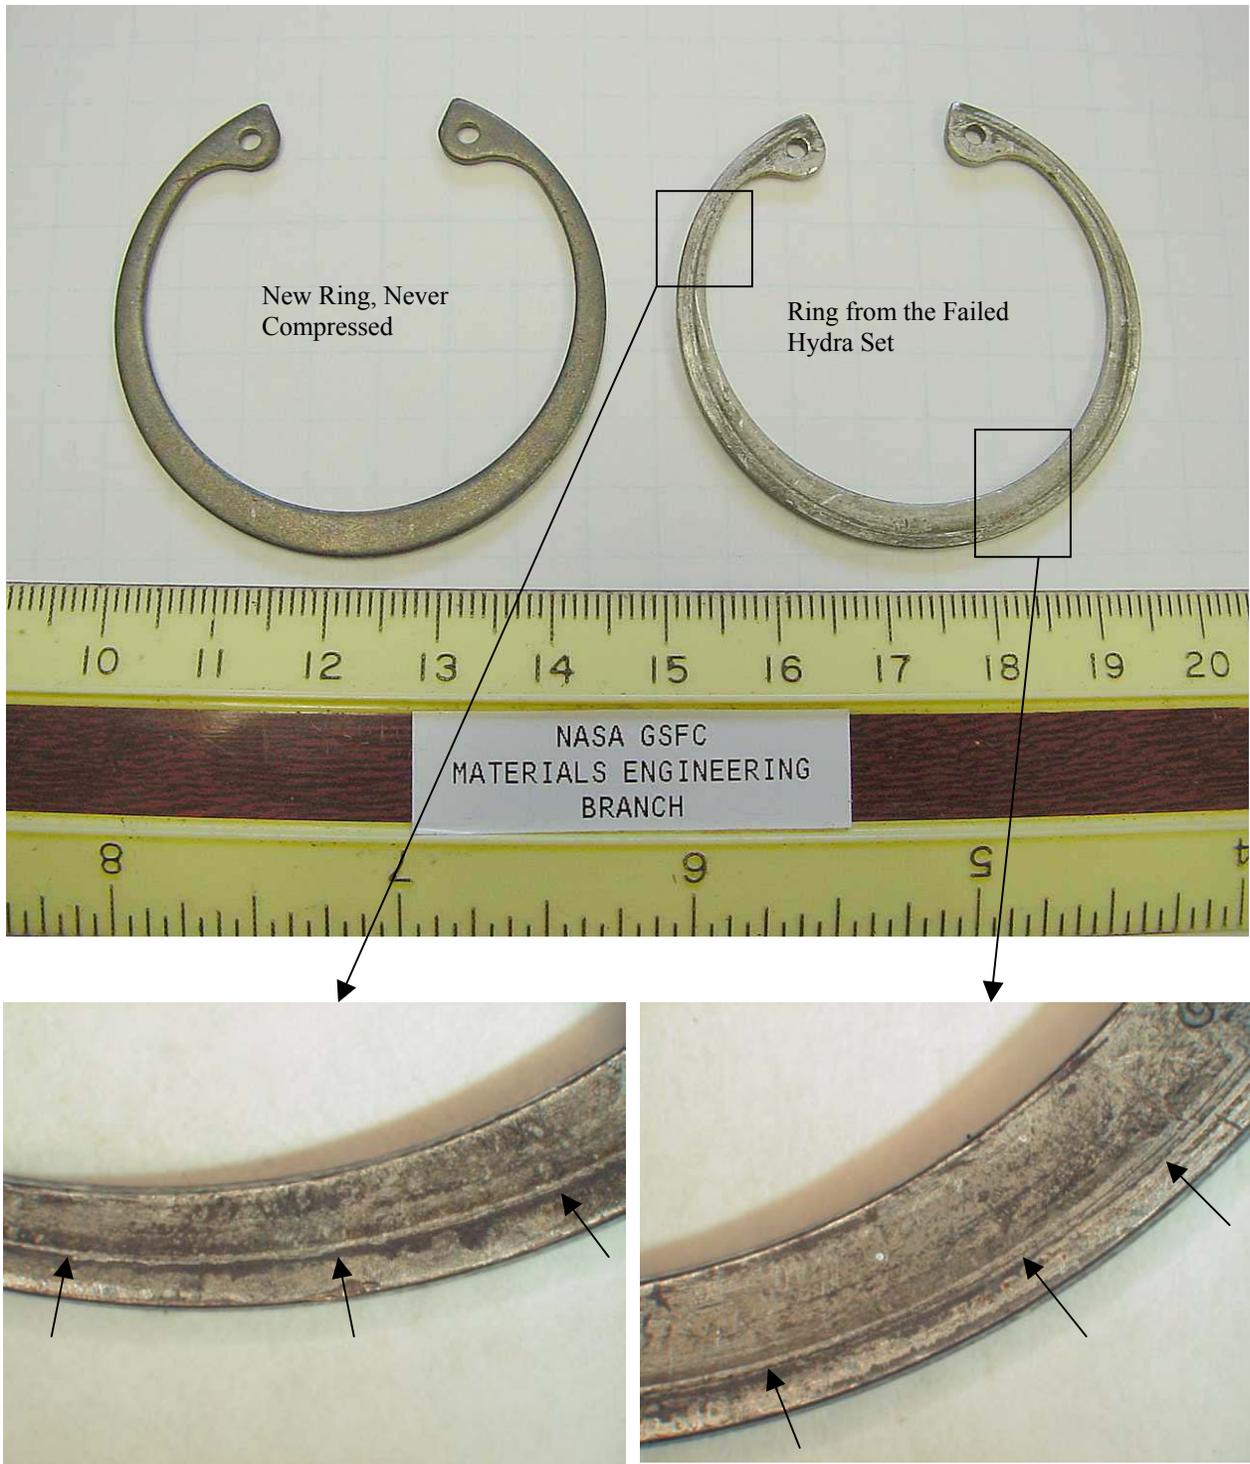
On both sides of the ring, the zinc plated surface had characteristic circumferential lines, as shown in Fig.4. Most likely these lines were the “foot prints” left on the zinc surface by the abutting edge of the inner groove. The fact that both sides of the ring have these imprints indicates a multiple use of this ring in the subject Hydra-Set. Hardness readings taken on the ring resulted in an average Rockwell “C” values of 51.5. This value is well within the hardness range of Rockwell “C” 47-52 specified in the Waldes Truarc manual for the carbon spring steel rings.

Dimensional inspection of the ring performed in accordance with the manufacturer’s recommended inspection procedure resulted in the average ring free diameter of 1.737 in. This falls below the ring diameter range of 1.779 – 1.839 in specified by the ring and Hydra-Set manufacturers. In addition, the ring was not flat but twisted slightly out of plane, see. Fig.5. The ring thickness was found to be 0.064 in., which agreed well with the manufacturer’s specification of 0.062 +/- 0.003 in.

FIG. 4. A side-by-side view of the two Internal series N5000 W 162 rings (top) and the close-ups of the failed ring showing “foot print” line running around the entire circumference on both sides of the ring.

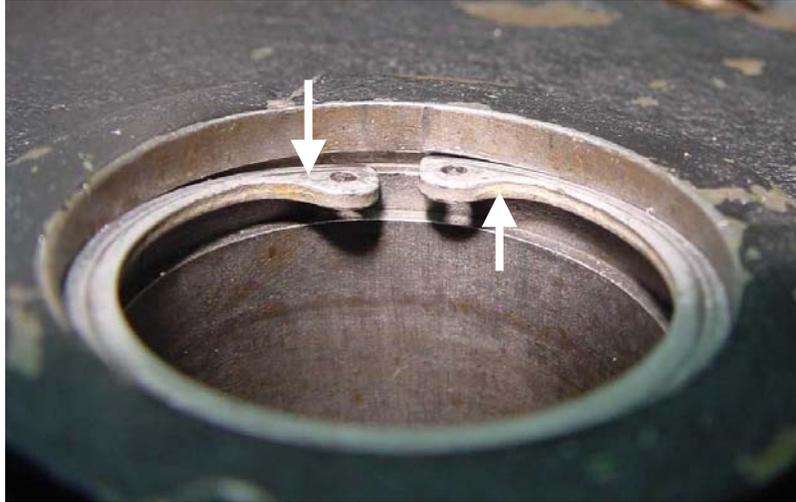
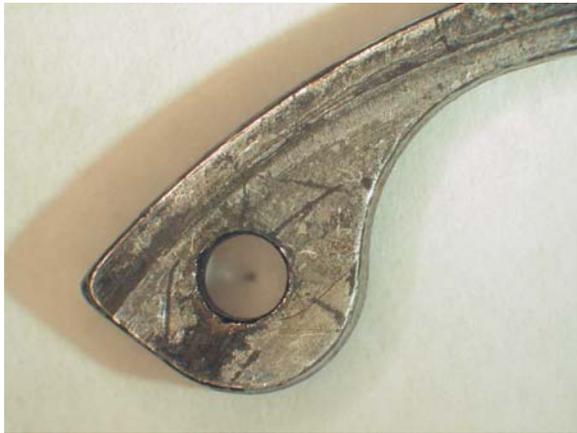
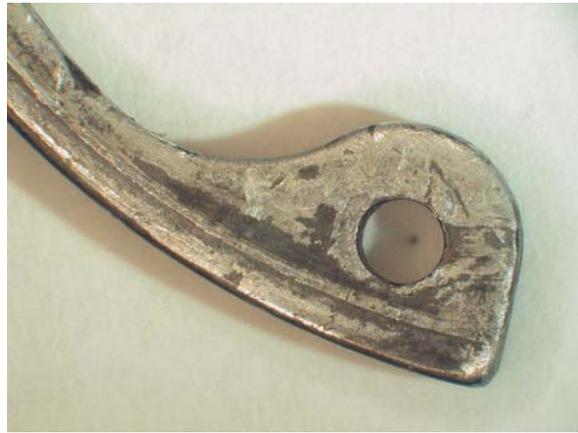
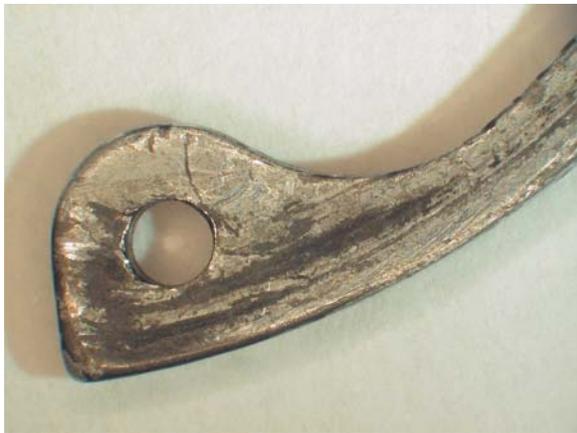
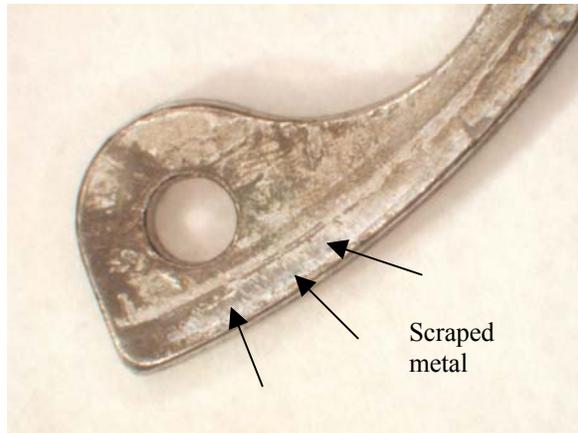
Other than the “foot print” lines, the surface of the ring is relatively featureless except for one corner of one lug showing some evidence of scraping, as shown in Fig.5

Since the components of the ring assembly were found to be intact with no evidence of physical damage, the Investigation Team believes that the ring became almost fully unseated prior to leaving the inner groove completely. It appears that only a corner of one lug was still keeping the ring in place when it finally was forced out of the groove during the last Hydra-Set exercise. Close examination of the abutting groove edge revealed a small flared portion of the edge and the two vertical scratch marks on the surface of the bore, as shown in Fig. 6. These features are consistent with the surface markings that would have been left by the retaining ring “walking out” of the groove with one of its lugs still partially located inside the groove. Most likely this was the lug that has some evidence of scraping action on the plated surface of one of its corners, as shown in Fig. 5.

FIG.5 The lugs in failed ring are slightly bent out of plane as indicated by white arrows (top). Here, the failed ring was partially re-installed into the lower head to illustrate the ring deformation. Photos A-D provide close-ups of all four corners of the lugs. Only corner D shows some scraped zinc plating.

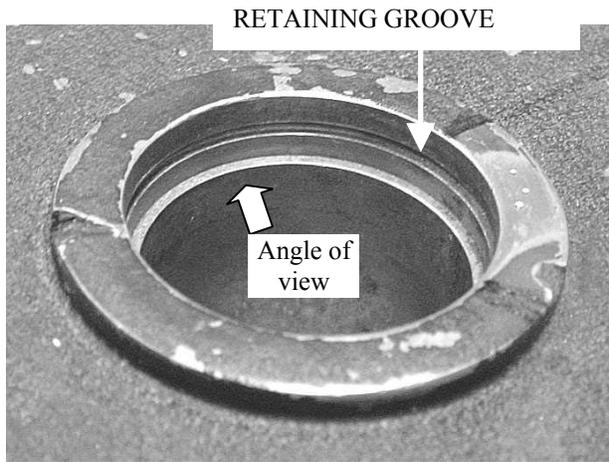
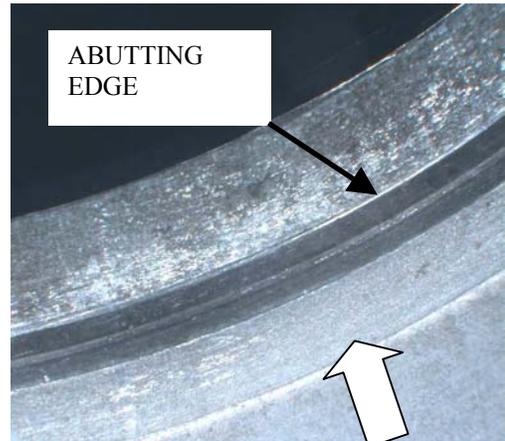
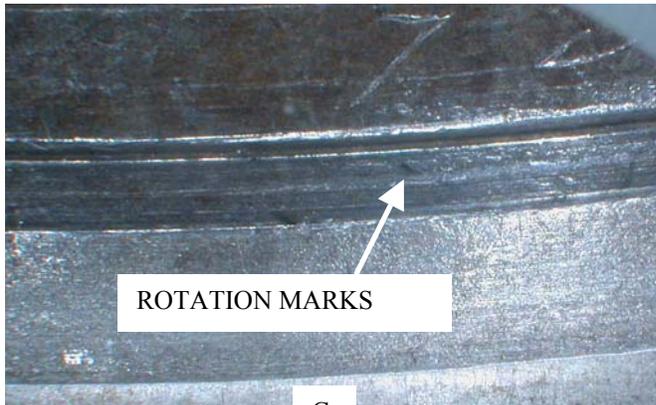
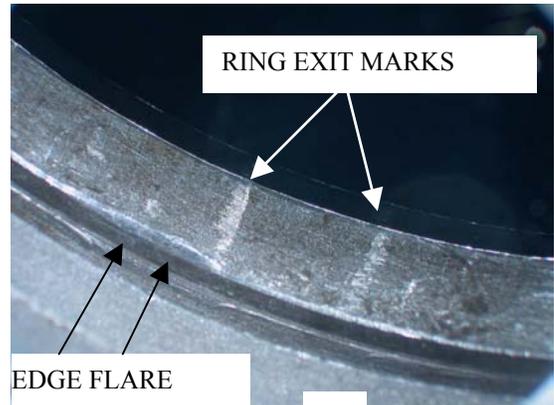
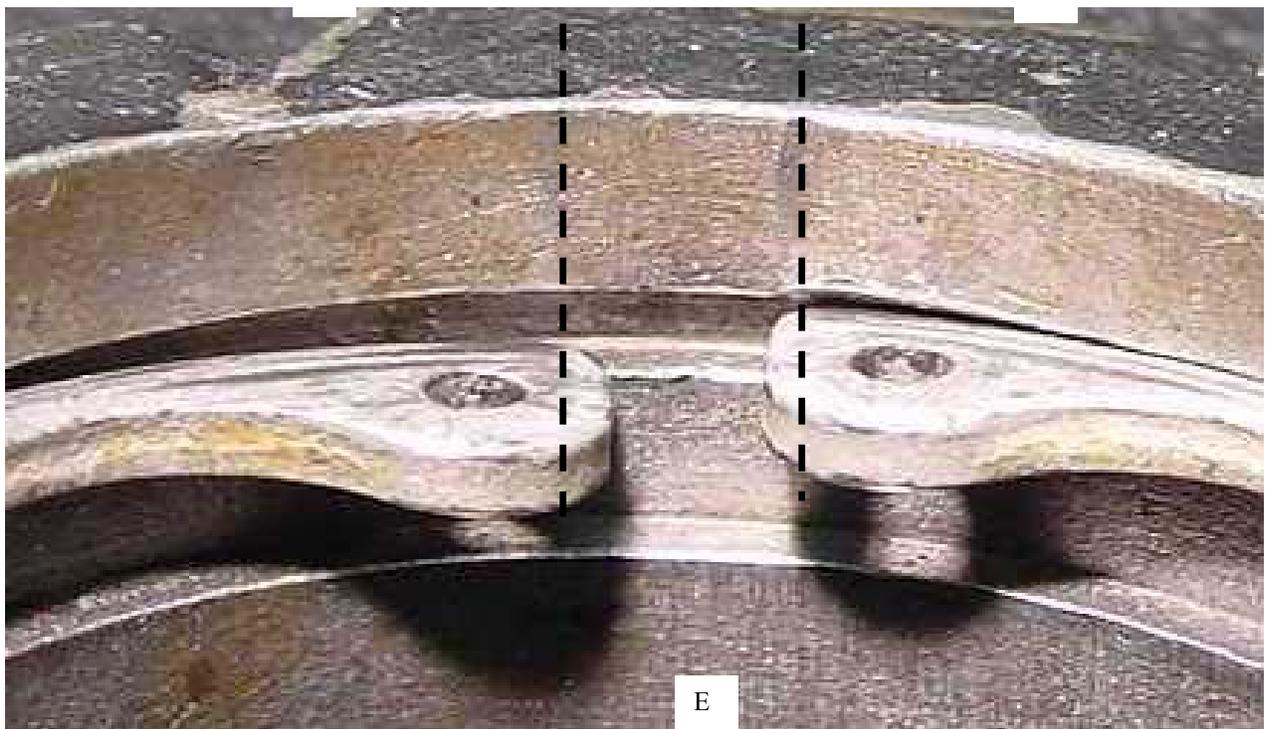
The lower head was visually inspected for possible damage or defects around and inside the inner groove. The groove edge that supports the axial thrust load was found to be sharp and physically intact. In one location, the edge was slightly deformed as shown in Fig. 6. In the same location one can see two vertical marks on the inside surface of the lower head bore. These marks extend all the way from the groove edge to the outside edge of the bore. In several locations, the groove bottom had some circumferential scratch marks, as shown in Fig.6

FIG.6. Top photos show inner groove (A) and a typical appearance of the abutting edge (B). Note the angle of view used to take a close-up photo. Some rotation marks can be seen on bottom of the groove (C). View D reveals two vertical marks and some edge damage possibly left by the ring lugs on the way out. The distance between vertical marks (dashed lines) is very similar to the gap between the lugs when the ring is about to come out of the groove (E).

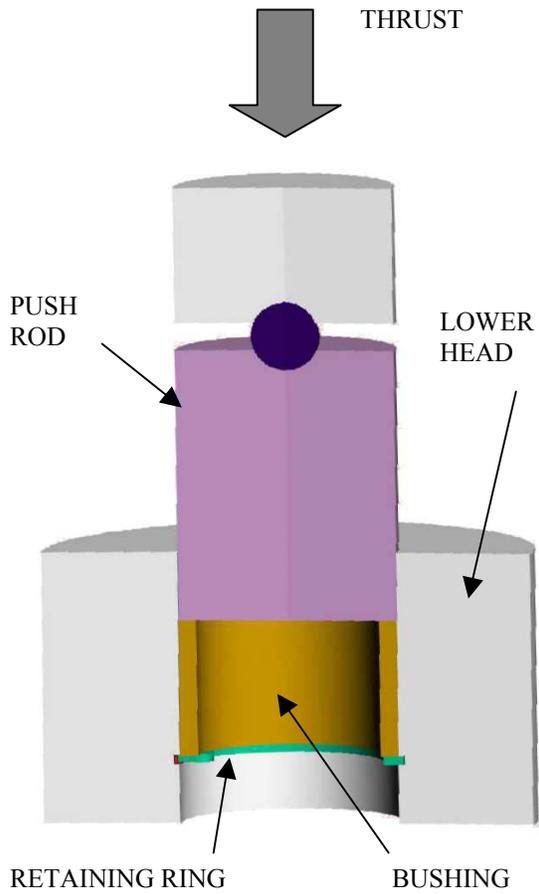
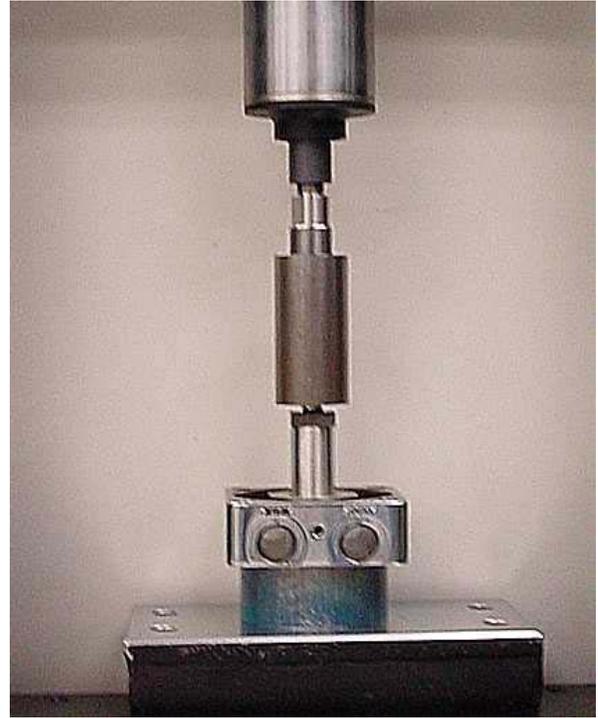
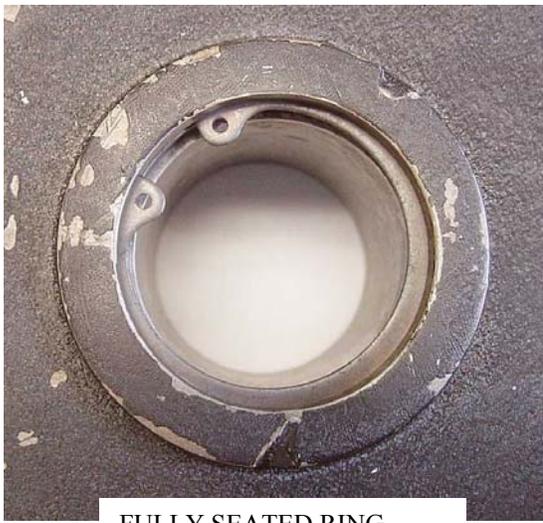
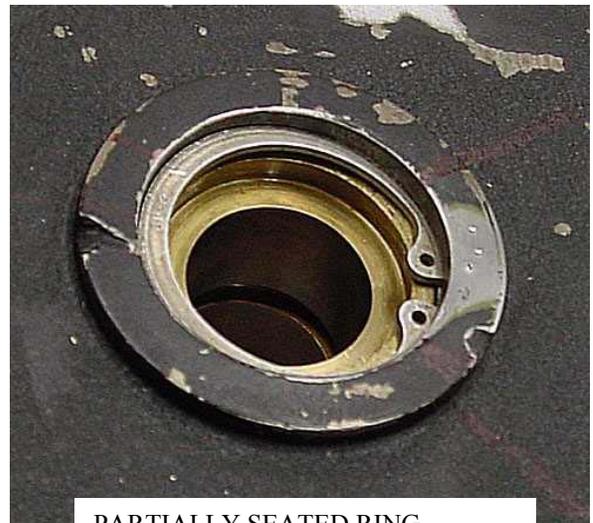
In order to better understand the behavior of the retaining ring and other components inside Hydra-Set under load, it was decided to perform a static compression test. The test was not designed to replicate the exact hydraulic interaction between the components. The test provided an approximate simulation of the partially seated retaining under static load. The investigation team felt that the test could be beneficial in determining the ability of a partially seated retaining ring to support static axial thrust loads. This, in turn, might lead to some clues as to what the possible failure mechanisms of the Hydra-Set were. The test schematic is shown in Figs.7 and 8. Table 2 contains a summary of all static tests performed.

FIG.7 A schematic 3D cross sectional view of the static compression test (top left) showing application of the axial thrust on fully seated retaining ring. Top right photograph depicts the actual test setup. Bottom photos show fully seated (left) and one of the possible orientations of the partially seated (right) ring.

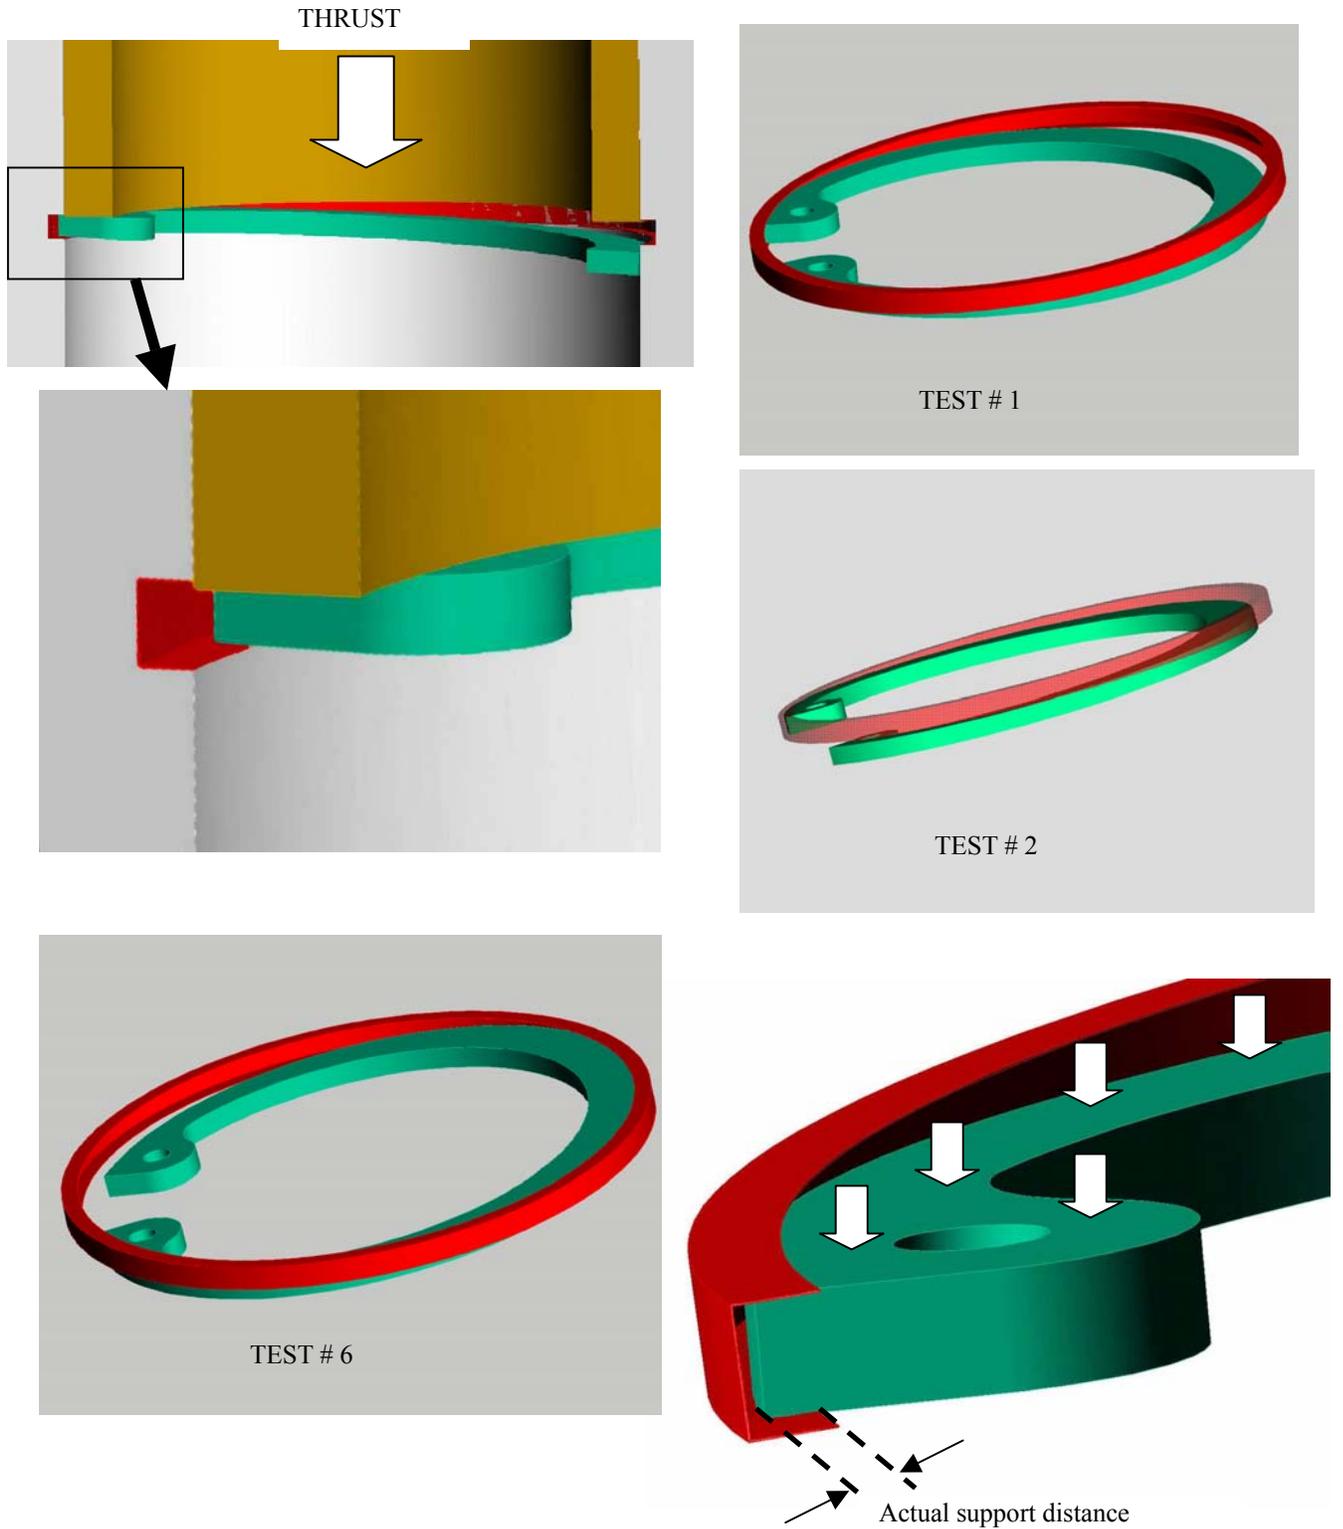
Another condition that can cause the ring to slip out of the groove when the Hydra-Set is under load is an incomplete or partial installation of the ring. It is possible to assemble the Hydra-Set with only partially installed retaining ring, since the unit does not have any design features that would preclude the incorrect seating of the retaining ring. Moreover, as the static test confirmed (see tests ## 1,2,3 and 7 in Table 2), a partially seated retaining ring can support static thrust loads as high as 1000 lbs! This means that depending on the Hydra-Set service conditions, a partially installed retaining ring may not “walk out” of the groove right away on the first loading cycle! Rather it continues to perform “normally” until the loading conditions change (static to dynamic) or it slowly creeps out of the groove if subjected to sustained loads over a long period of time. The amount of axial static thrust required to unseat a partially seated ring depends on its degree of misalignment, see Fig.8. For example, the static test demonstrated (see tests ## 4 and 6 in Table 2) that it might take as little as 25 lbs or as much as 786 lbs to force a partially seated ring out of the groove.

FIG.8 A schematic 3D view of the partially seated retaining ring under axial load (top left). Also shown schematically are various positions of the partially seated ring during compression test. Depending on the actual support distance it may take different amount of thrust (white arrows) to unseat the ring.
